DEPARTMENT OF TRANSPORTATION**DIVISION OF ENGINEERING SERVICES**

Contract #: 04-0120F4Cty: SF/ALA Rte: 80 PM: 13.2/13.9File #: 1.28**WELDING INSPECTION REPORT****Resident Engineer:** Casey, William**Address:** 333 Burma Road**City:** Oakland, CA 94607**Report No:** WIR-028367**Date Inspected:** 09-Sep-2012**Project Name:** SAS Superstructure**OSM Arrival Time:** 700**Prime Contractor:** American Bridge/Fluor Enterprises, a JV**OSM Departure Time:** 1930**Contractor:** American Bridge/Fluor Enterprises, a JV**Location:** Job Site**CWI Name:** Salvador Merino**CWI Present:** Yes No**Inspected CWI report:** Yes No N/A**Rod Oven in Use:** Yes No N/A**Electrode to specification:** Yes No N/A**Weld Procedures Followed:** Yes No N/A**Qualified Welders:** Yes No N/A**Verified Joint Fit-up:** Yes No N/A**Approved Drawings:** Yes No N/A**Approved WPS:** Yes No N/A**Delayed / Cancelled:** Yes No N/A**Bridge No:** 34-0006**Component:** SAS OBG**Summary of Items Observed:**

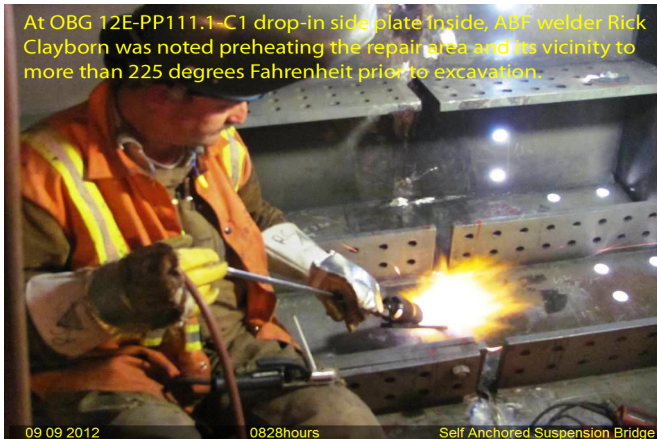
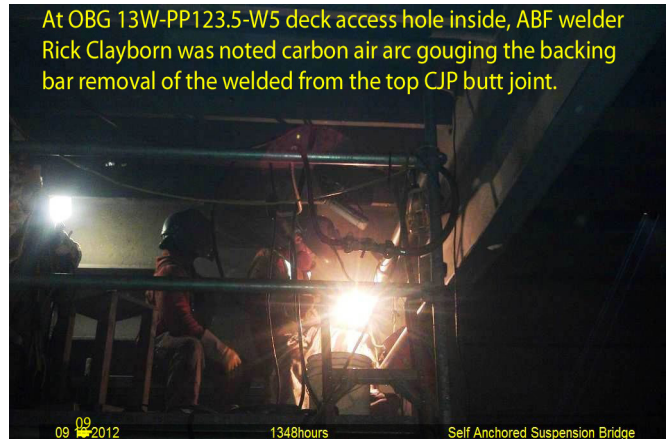
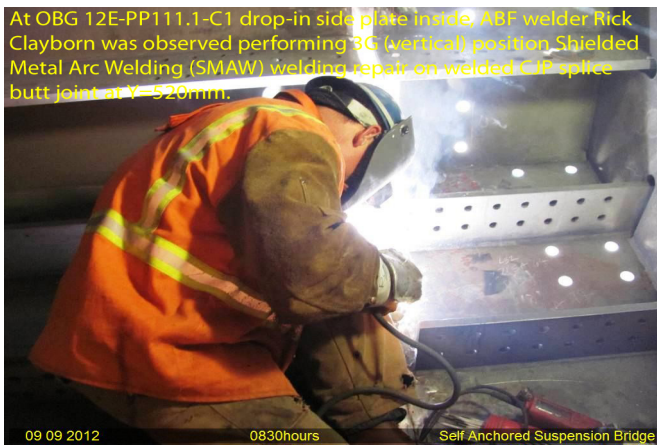
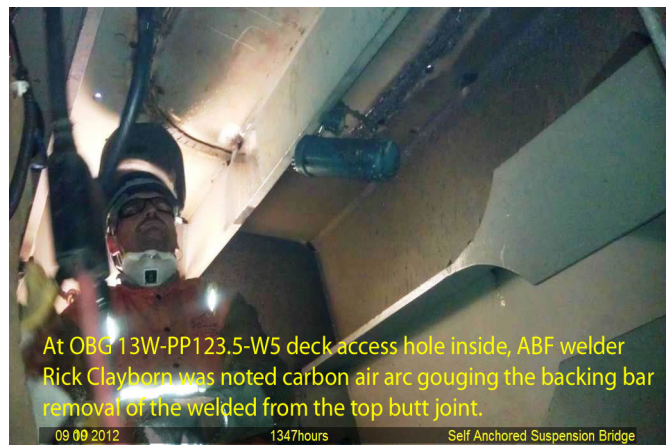
At OBG 12E-PP111.1-C1 drop-in side plate outside, QA randomly observed ABF/JV qualified welder Rick Clayborn continuing to perform CJP groove welding repair on a Seismic Performance Critical Member (SPCM) due to Ultrasonic Testing (UT) detected defect on welded splice butt joint. The welder was given approval to excavate one repair per Caltrans approved Request for Weld Repair (RWR) #201209-066. The welder preheated the repair area and its vicinity to >225°F prior excavation and then ground smooth the groove of the excavation. After its completion, ABF QC Salvador Merino performed Magnetic Particle Testing (MT) on the removal of the defect with no relevant defect noted during the test.

The welder was noted using propylene gas torch to preheat the repair area and its vicinity to 325°F and as soon as the required temperature was attained the welder started performing the welding repair. Welder Rick Clayborn was observed manually welding in 3G (vertical) position utilizing Shielded Metal Arc Welding (SMAW) with 3.2mm diameter E7018H4R electrode implementing Caltrans approved welding procedure ABF-WPS-D15-1004 Repair. Welder Rick Clayborn was noted welding repair at Y=520mm having boat shape excavation profile of 140mm long x 20mm wide x 11mm deep. During welding, ABF QC Salvador Merino was noted monitoring the welders' welding parameter with measured working current of 143 amperes on the 3.2mm diameter E7018H4R electrode. After the welding completion, the another ABF personnel performed the Post Weld Heat Treatment (PWHT) of 450°F using propylene gas torch and held it for one hour as required. The welder has moved to OBG 13W-PP123.

At OBG 13W-PP123.5-W5 deck access hole inside, the same welder was noted removing the backing bar using carbon air arc gouging. After the removal of the backing bar, the welder also carbon air arc gouged the back side of the (welded root pass to cover pass from the top) CJP butt joint and followed with smooth grinding before ABF QC John Hayes performed Magnetic Particle Testing (MT) on the backing bar removal. The welder performed 4G (overhead) back welding fill pass using 3.2mm diameter E7018H4R electrode implementing Caltrans approved welding procedure specification ABF-WPS-D15-1110A Rev. 1 until the end of the shift. Fill pass back welding should remain tomorrow.

1. 12E-PP16.5-E5 LSW longitudinal stiffener inside - splice butt joint weld cover QA verified.
2. 13W-WK retrofit stiffener – 8mm fillet weld both sides cover QA verified.
